*In more detail... the coastal composition of Lyme Regis*

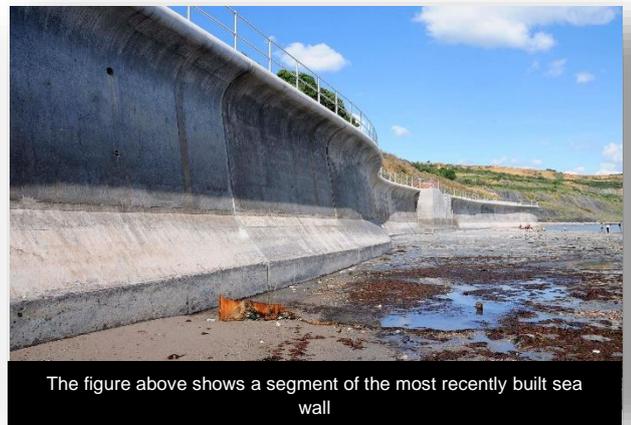
The figure above shows a segment of the most recently built sea wall

**Phase 4:** Between 2013 and 2015, a northerly new sea-wall was built to provide protection to the coastal paths surrounding the town, and more cliff stabilization aimed to protect 480 homes from collapse.
